Stainless Steel

More than a hundred different versions of stainless steel are available. But some are more suitable than others for marine applications.

TEXT & PHOTOS BY
JONATHAN KLOPMAN

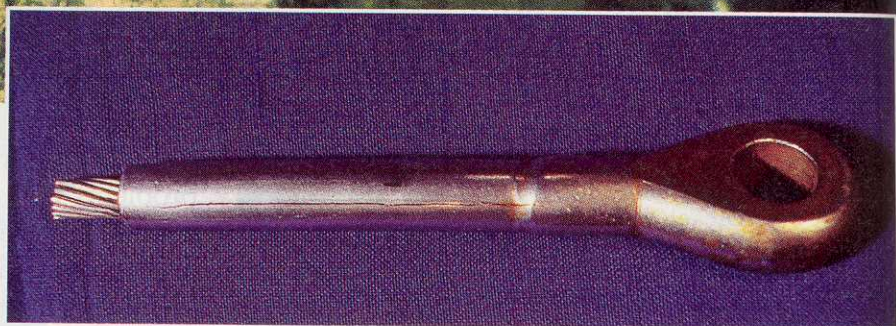
Facing page—An overall view and detail of stress-corrosion cracking in a stainless steel swage fitting, taken from the tuned rig of a sailboat. This type of failure is initiated by parts being under a tensile load in the presence of chlorides. The chloride element here is visible as salt crystals inside the crack. Note how the scratches and pits on the surface of the stainless become apparent at 100x magnification. **Right**—The 300-series austenitic grades of stainless are typically found in marine applications. For general service, the most common grades are 304 and 316.

Stress-corrosion cracking is the premature failure of a part, initiated by tensile stress in a chloride-rich environment. The failures are typically fine, jagged-edged cracks perpendicular to the tensile load. Elevated temperatures (generally over 2,500°F) as well as low pH are known to exacerbate the problem.

Although no studies have replicated stress-corrosion cracking in austenitic grades of stainless steel, I still suspect that it does occur. Any rigger can confirm that swage fittings at deck level tend to crack, and that the problem seems to be far worse in tropical climates. The greatest worry, though, is not the crack in the fitting but the condition of the wire in the swage. (See my article "Analyzing Failed Metal Parts," PBB No. 51, page 56.)

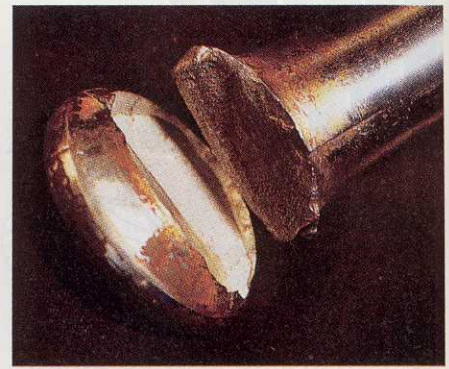
*Crevice corrosion in stainless is often found in areas hidden from view. Some examples: a rudder pin that looks as if it was attacked by teredo worms (**below, left**), a keelbolt from a wooden boat (**above, left**), and a rod-rigging cold bead from a large yacht (**right**). In all cases, the corrosion could only be observed by disassembly.*

damage at the back, or faying, surface. Especially in the case of fittings below the waterline, the installation of the part itself creates oxygen-starved nooks and crannies that can initiate pits.

Crevice corrosion is common under the heads of fasteners, on chainplates where they pass through the deck, and on sailboat rudder stocks inside a fiberglass shell. The probability of corrosion depends on the gap and depth of the crevice (narrow, deep cracks are a bad thing), as well as on the grade of alloy.

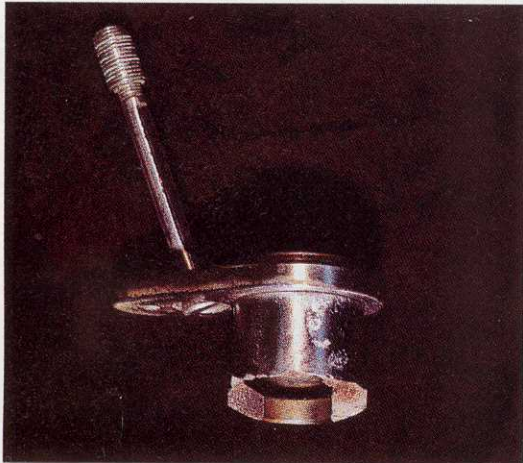
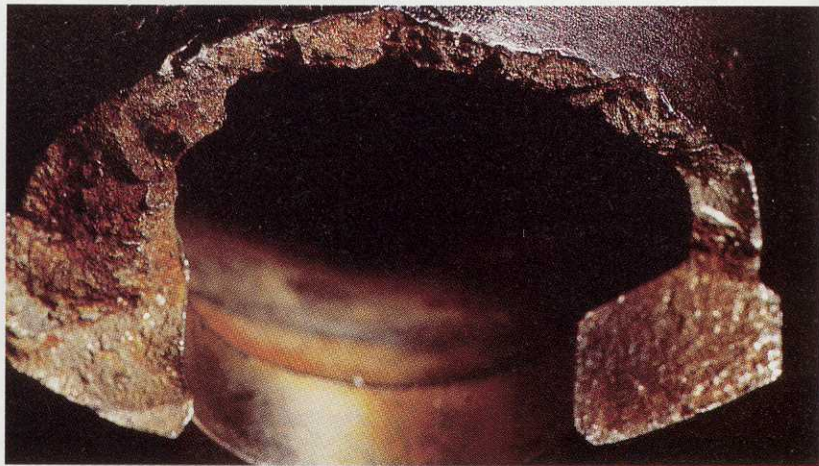
Below—Note how the nobility of stainless steel shifts from passive to active when immersed in the anaerobic environment of salt water.

Galvanic Series in Flowing Seawater*

Graphite	+200 > +300
Platinum	+190 > +250
Hastelloy C (Nickel based, 16% Mo)	-30 > +80
Titanium	-50 > +60
Aquamet 22/Nitronic 50 S.S. shafting	-250 > +60
316 S.S. (2% Mo) passive	-100 > 0.0
Monel (70% Ni, 30% Cu)	-140 > -40
304 (18-8) passive	-100 > -50
Inconel (78% Ni, 13.5% Cr, 6% Fe)	-170 > -140
Copper Nickel (70% Cu, 30% Ni)	-230 > -180
Lead	-250 > -190
Silicon Bronze	-290 > -260
Bronze (through-hull 85% Cu)	-310 > -240
Manganese Bronze	-340 > -270
410 S.S. (11% Cr) passive	-350 > -260
Admiralty Brass	-360 > -280
Red Brass	-400 > -300
Nibral (Nickel/Aluminum/Copper prop)	-420 > -310
Inconel active in still water	-460 > -350
316 S.S. active in still water	-540 > -430
304 S.S. active in still water	-580 > -460
410 S.S. active in still water	-580 > -460
Iron/Steel	-710 > -600
Aluminum	-1000 > -760
Zinc	-1030 > -980
Magnesium	-1630 > -1600

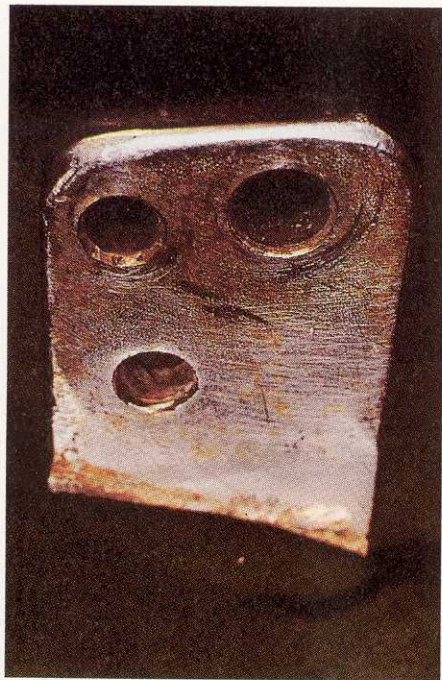
*A broken stemhead fitting from a sailboat. **Left**—The fitting looks as it did on deck, with no discernible corrosion. But once torn out, evidence of heavy corrosion and stress cracking becomes visible. The cause of failure is a combination of poor bedding at the deck and a bad weld. Improper welding technique leads to carbide precipitation, where the heat from welding leaves the alloy chromium-poor and susceptible to intergranular corrosion.*
